MIFACE Investigation Report: #12MI121

SUBJECT: Pipefitter Dies When Excavation Wall Collapses, Causing Water Tank to Rotate and Pin Him Against Excavation Wall

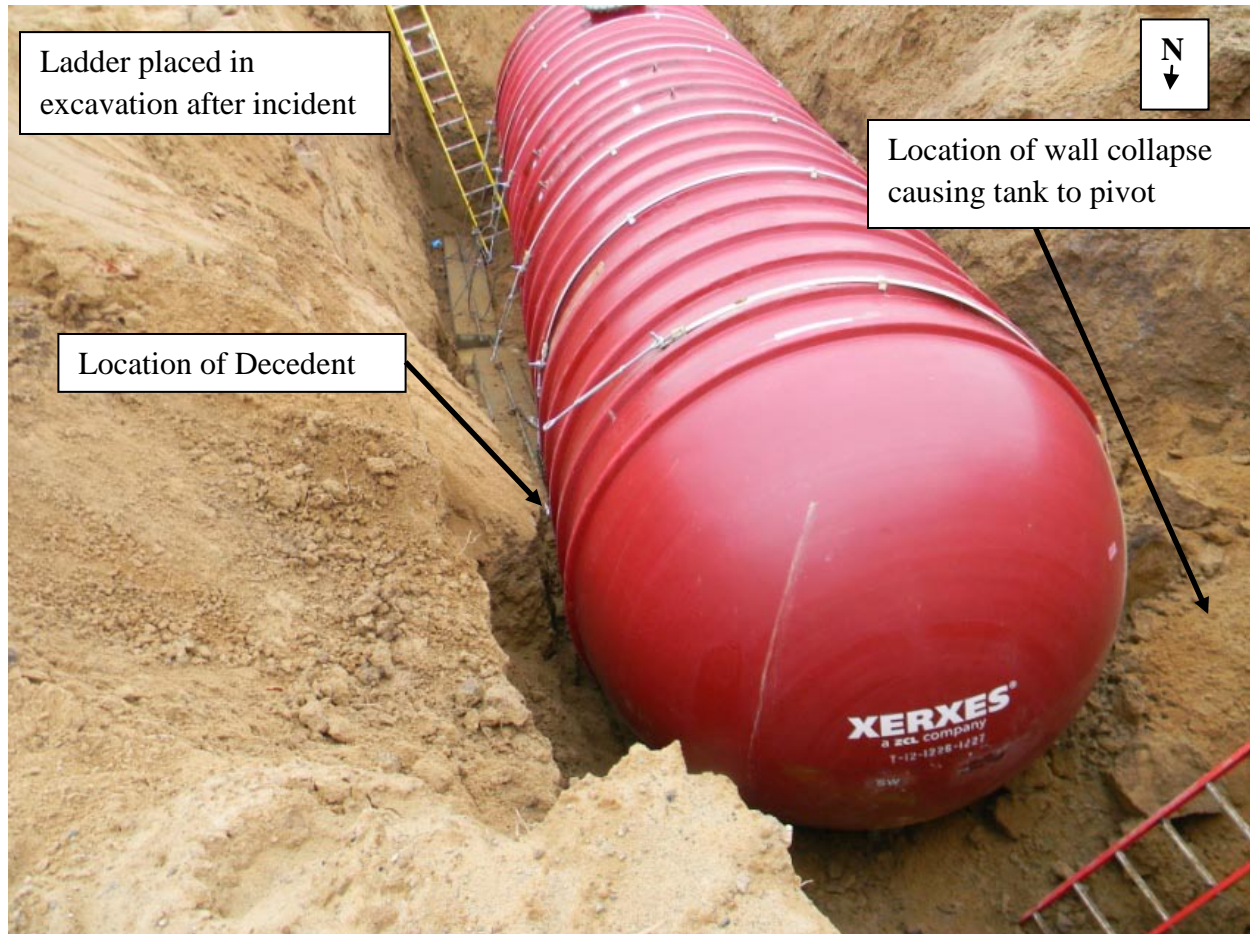
Figure 1. Position of water tank in excavation after trench wall collapse.

In fall 2012, a male sprinkler fitter/pipe fitter in his 40s died when he was struck by and pinned against the wall of an excavation by a water tank which had pivoted due to an excavation wall collapse (Figure 1). The excavation was dug by another contractor, who was the designated competent person. The soil was water saturated clay. Two feet of fill sand was atop the clay. The excavation had been partially completed the day prior to the incident and completed the day of the incident. The excavation was approximately 40 feet long by 14 feet wide by 14 feet deep. The excavation walls were nearly vertical and were not shielded or shored against collapse. It rained the night prior to the incident. On the day of the incident, the excavator operator

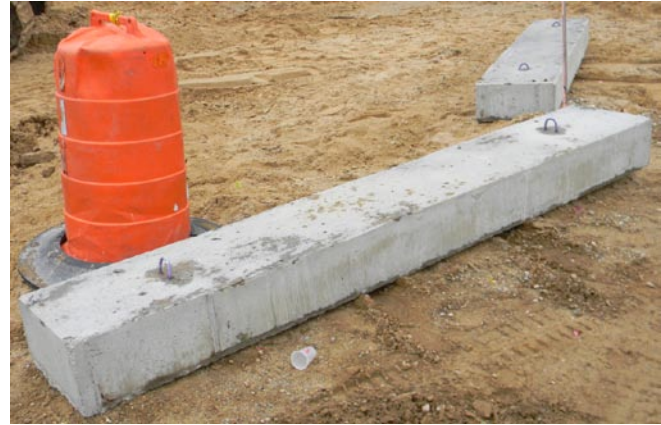
Figure 2. Concrete deadman anchors used on east and west sides of trench

The crew unloaded the water tank and waited for the concrete anchors to arrive (Figure 2). Coworker 2 arrived at approximately 9:30 a.m. Coworker 2 called the company office to find out when the anchors would arrive; he was told they would be onsite between 10:00 a.m.-10:30 a.m. The anchors should have been delivered the previous day or to have been on site no later than 8:00 a.m. on the day of the incident.

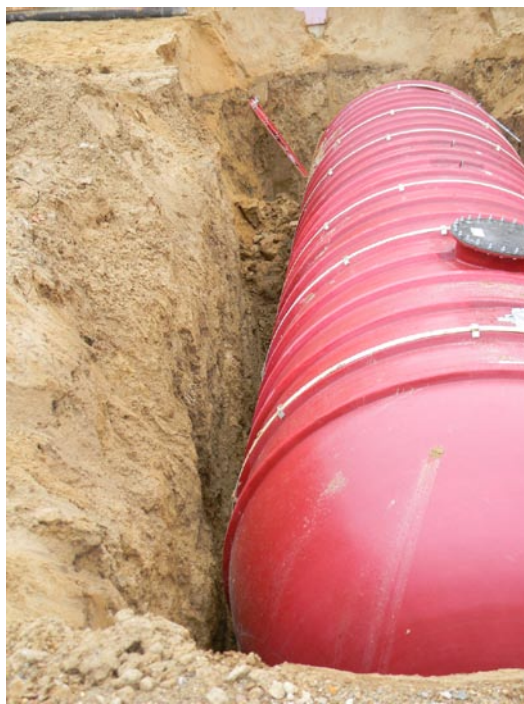
Figure 5. Collapsed soil in northwest corner causing tank to pivot to the east trench wall

Employees of this contractor entered and were working in an excavation that was approximately 40 feet long, 14 feet wide, and 11 feet deep, excavated by another employer. The employees were installing a 20,000 gallon water tank, when the northwest side of the excavation collapsed, pinning one employee between the tank and the opposing side of the excavation, resulting in fatal injuries to the employee. The west side of the excavation was

sloped to approximately 74 degrees, the east side was sloped to approximately 78 degrees, and the south side was sloped to approximately 73 degrees. Soil conditions were saturated, stiff clay with approximately 2 feet of sand fill at the top.

- Employers should ensure when employees are working in excavations that require a supporting system that a supporting system is implemented in accordance with MIOSHA standards.

Employers should consult Table 1 in the MIOSHA Excavation Standard that details the maximum allowable angle of repose for the side of an excavation in excess of five-foot depth that is required depending upon the type of soil and environmental conditions present at the site. Employers can consult with manufacturers of protective systems to obtain detailed guidance for the appropriate use of these products. The Appendix in Part 9 has examples of good engineering practices based on the rules of Part 9.
